ROCKFORD SAND AND GRAVEL

# CERCLA Integrated Site Assessment

**Illinois Environmental  
Protection Agency**

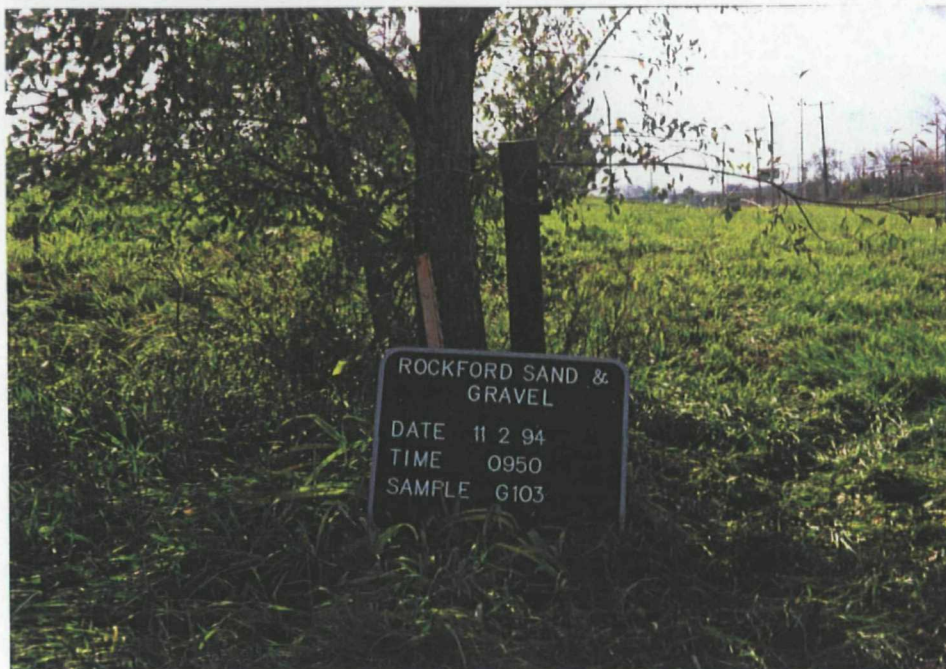
PICTURE TAKEN TOWARD  
the south.

Sample location G103.  
This well is located  
approximately 125 feet  
east of South Main Street  
(Route 2) which is to the  
right in the photo and  
approximately 240 feet  
north of the Laidlaw  
facility.

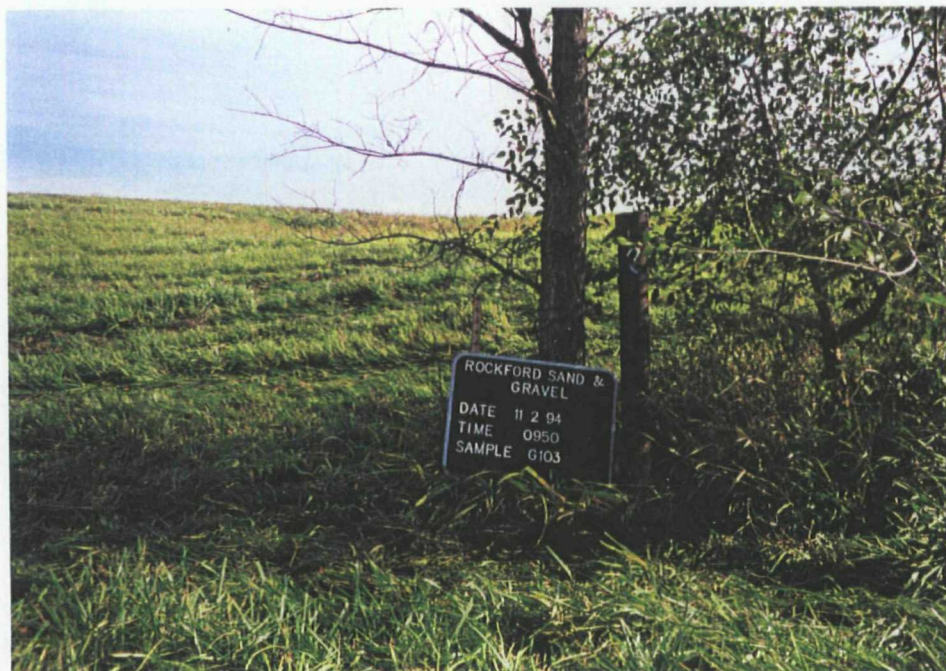
PICTURE TAKEN TOWARD  
the east.

Sample location G103.  
The well depth is 64.9  
feet deep. The berm at  
top left extends along  
the entire western edge  
of the property.

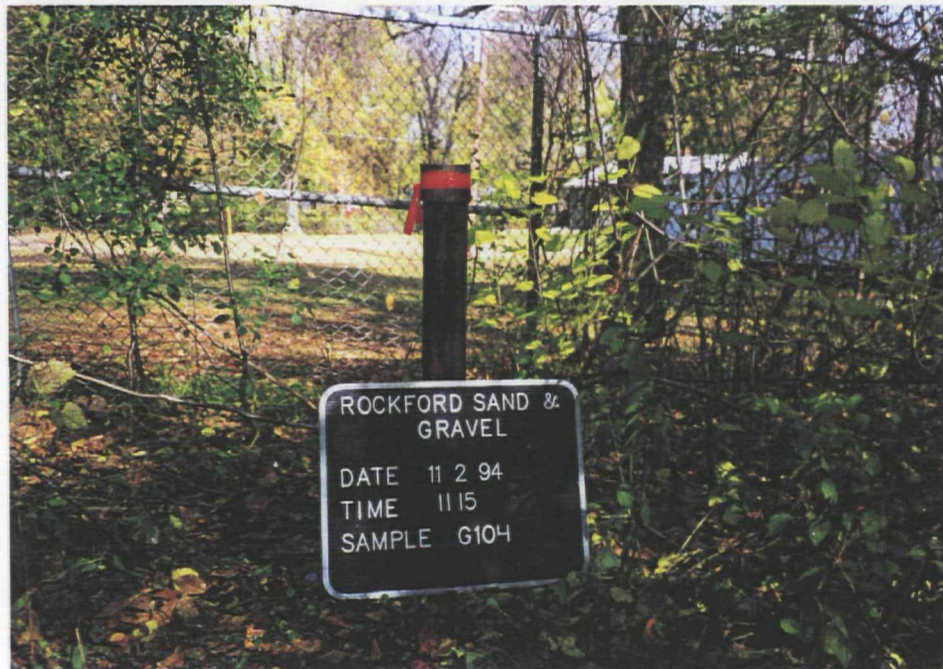
PICTURE TAKEN TOWARD  
the north.

Sample location G104 is  
located approximately  
900 feet east of South  
Main Street and is near  
the northern border of  
the property fence line.  
Private residences lie  
beyond the fence.

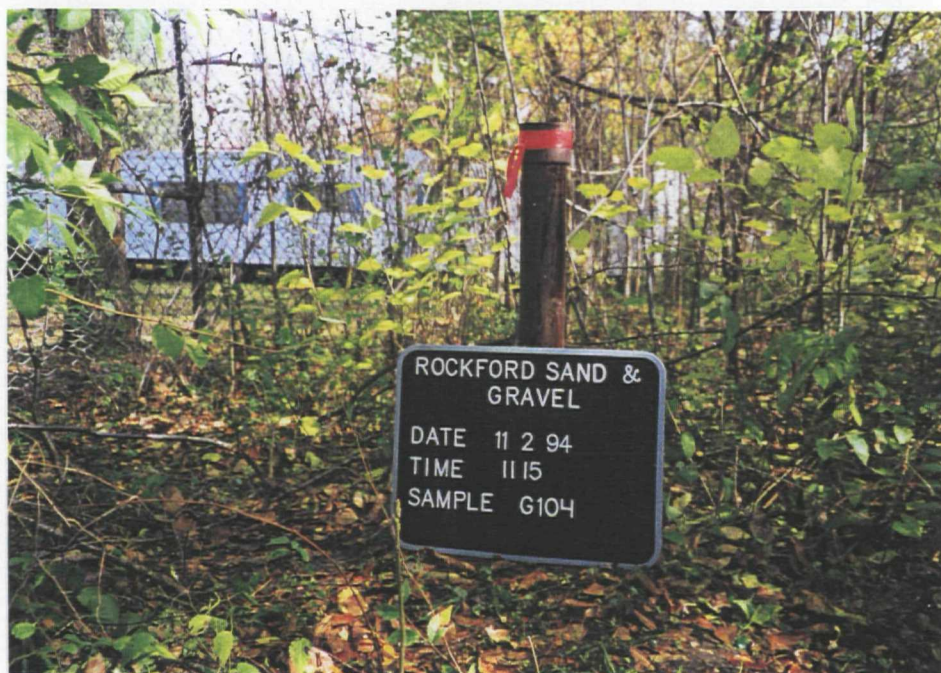
PICTURE TAKEN TOWARD  
the east.

Sample location G104. The  
private residences in the  
photo use groundwater for  
drinking. The monitoring  
well is 35.4 feet deep.

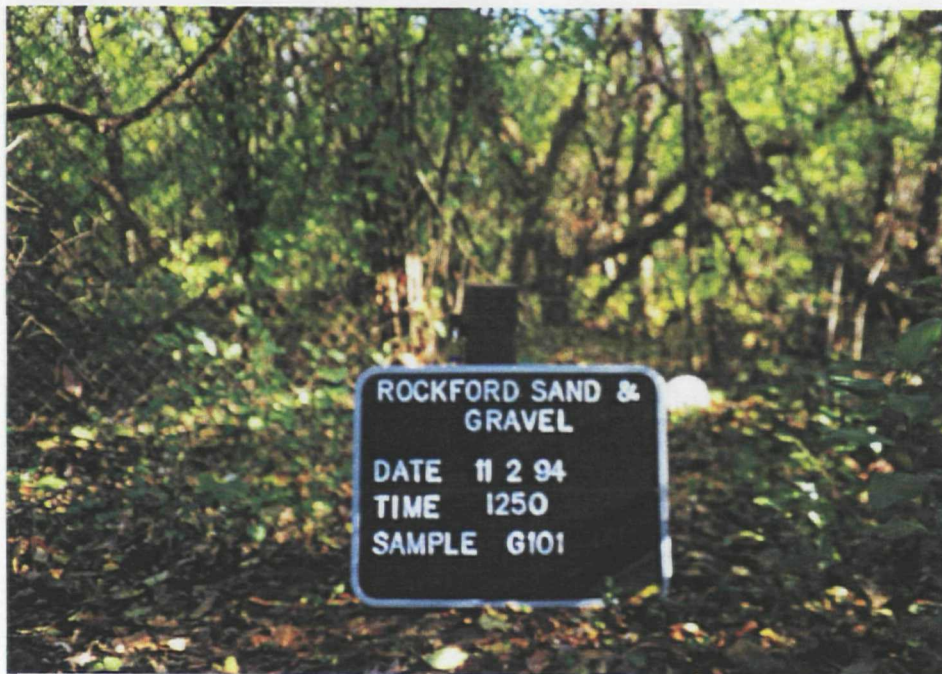
PICTURE TAKEN TOWARD  
the east.

Sample location G101 is located approximately 400 feet west of the Rock River and along the north-east area of the property. Private residences lie approximately 150 feet to the north.

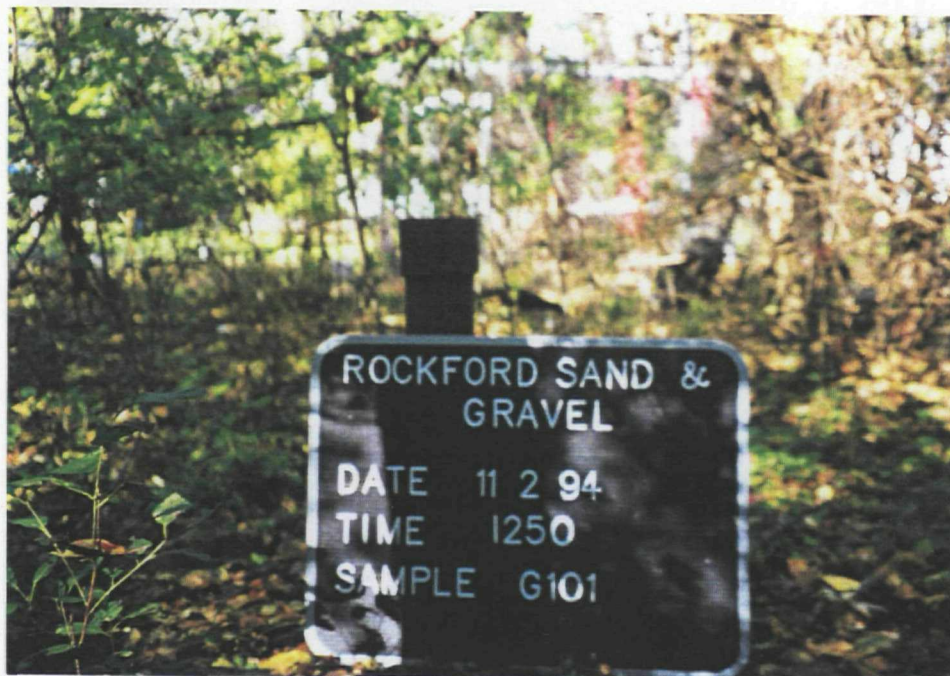
PICTURE TAKEN TOWARD  
the north.

Sample location G101. The well is 49.9 feet deep. Private residences lie in the background.

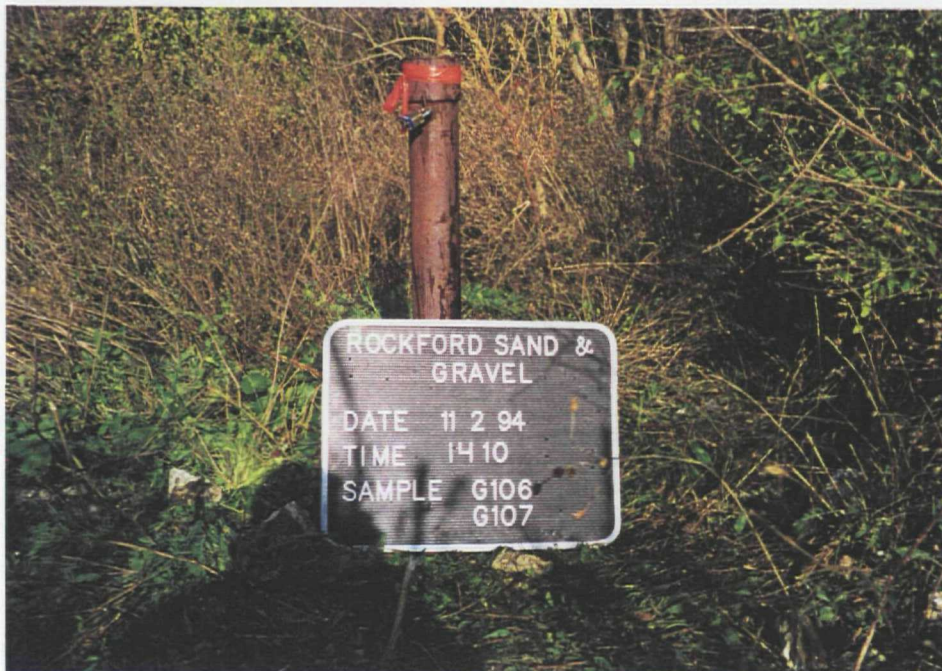
PICTURE TAKEN TOWARD  
the east.

Sample location G106 and  
duplicate G107. The well  
is 25.3 feet deep and  
located approximately 175  
feet west of the Rock  
River and 600 feet north  
of Simpson Road along the  
eastern area of the  
property.

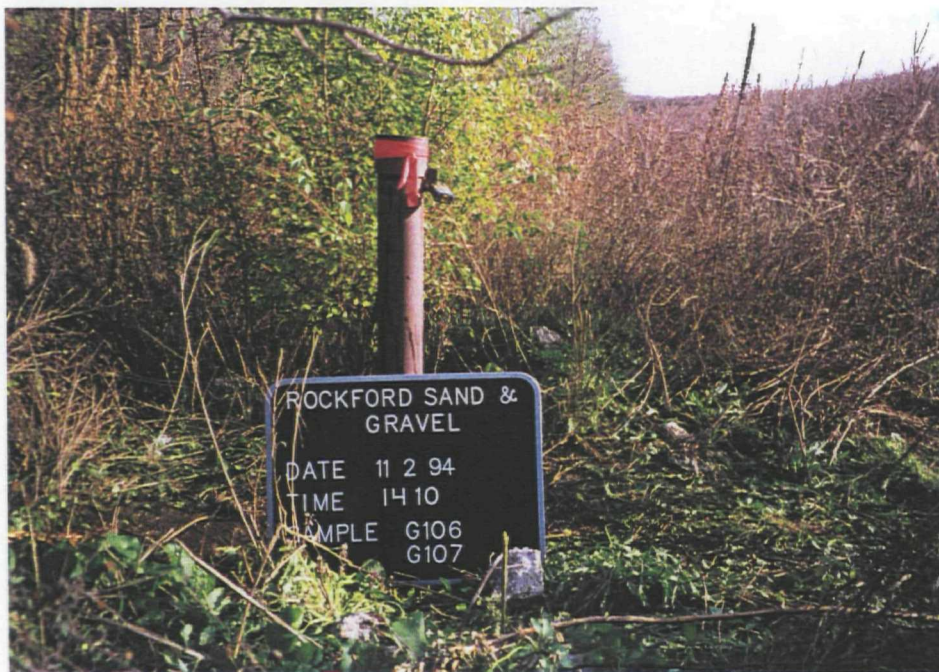
PICTURE TAKEN TOWARD  
the south.

Sample location G106 and  
duplicate G107. The Rock  
River is located approx-  
imately 175 feet to the  
left in the photo.

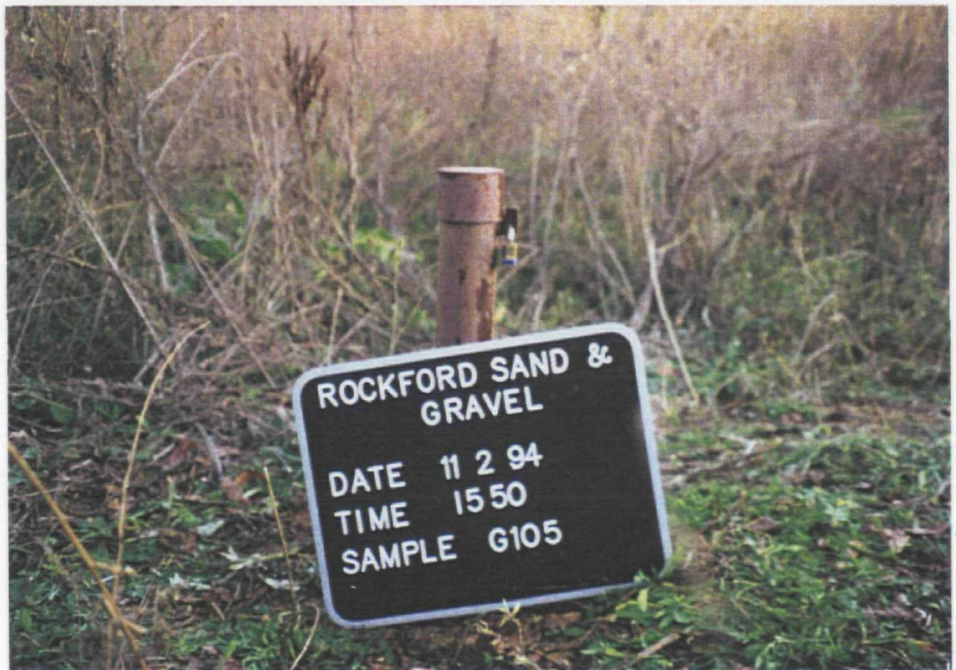
PICTURE TAKEN TOWARD  
the south.

Sample point G105. This  
monitoring well is 26.9  
feet deep and located  
along the eastern edge of  
the property approximately  
300 feet west of the Rock  
River and 600 feet north  
of Simpson Road.

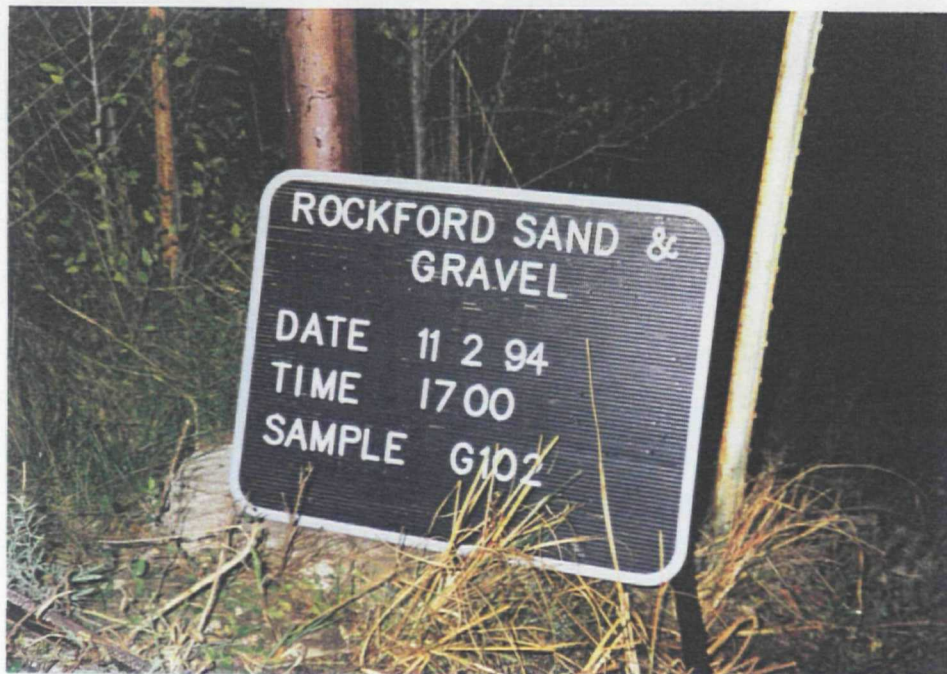
PICTURE TAKEN TOWARD  
the east.

Sample location G102.  
This well is 35.8 feet  
deep and located on  
Simpson Road at the east  
end of the property,  
approximately 400 feet  
west of the Rock River.

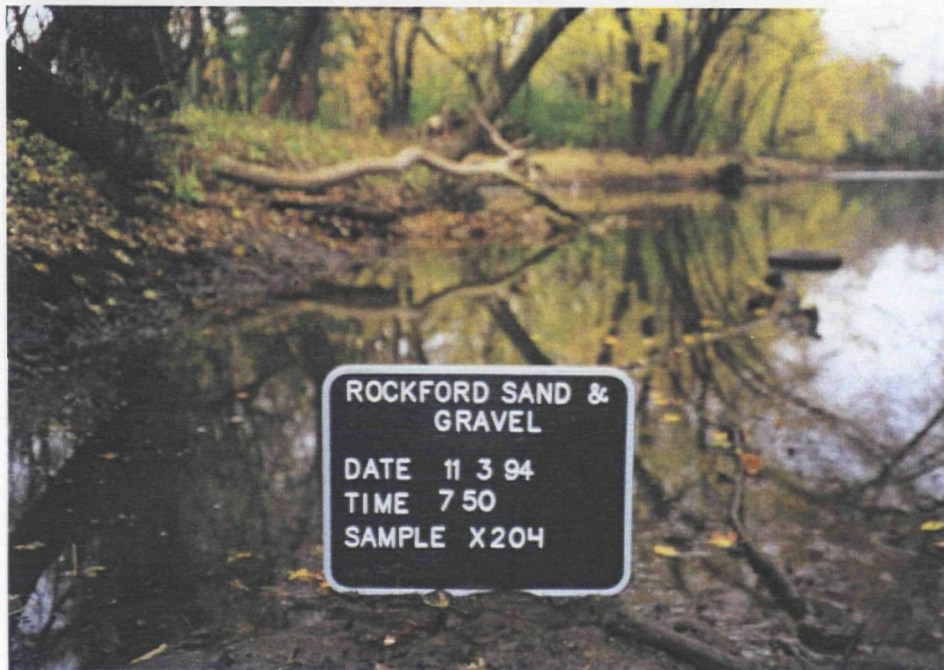
PICTURE TAKEN TOWARD  
the south.

Sample X204 was collected  
on an island located in  
the Rock River near the  
southeast corner of the  
property. The sediment  
was collected from a  
depth of 0 to 3 inches.

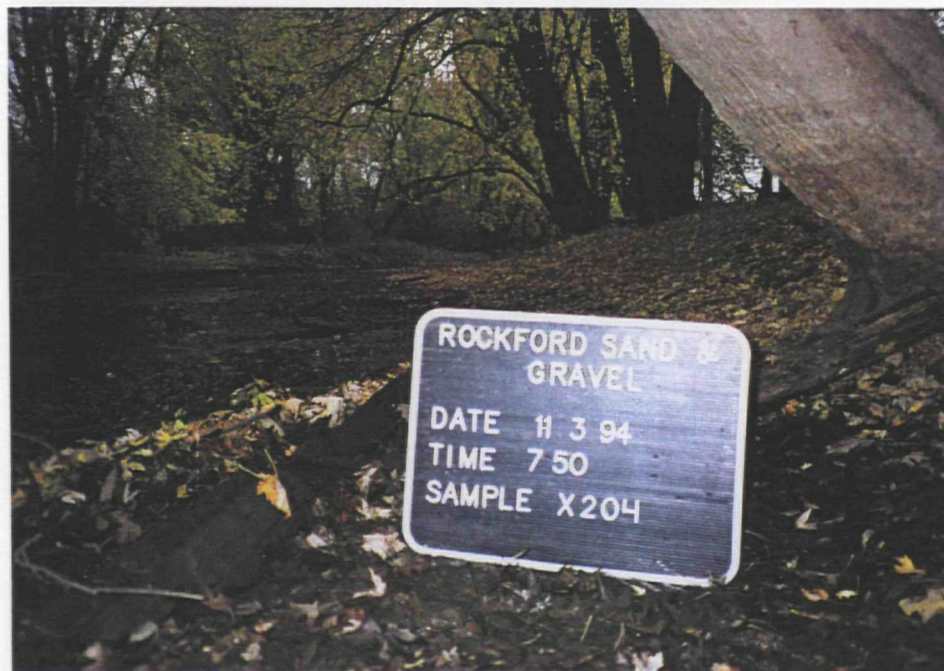
PICTURE TAKEN TOWARD  
the north.

Sample X204. The Rock  
River water level was low  
enough to access the  
island on foot.

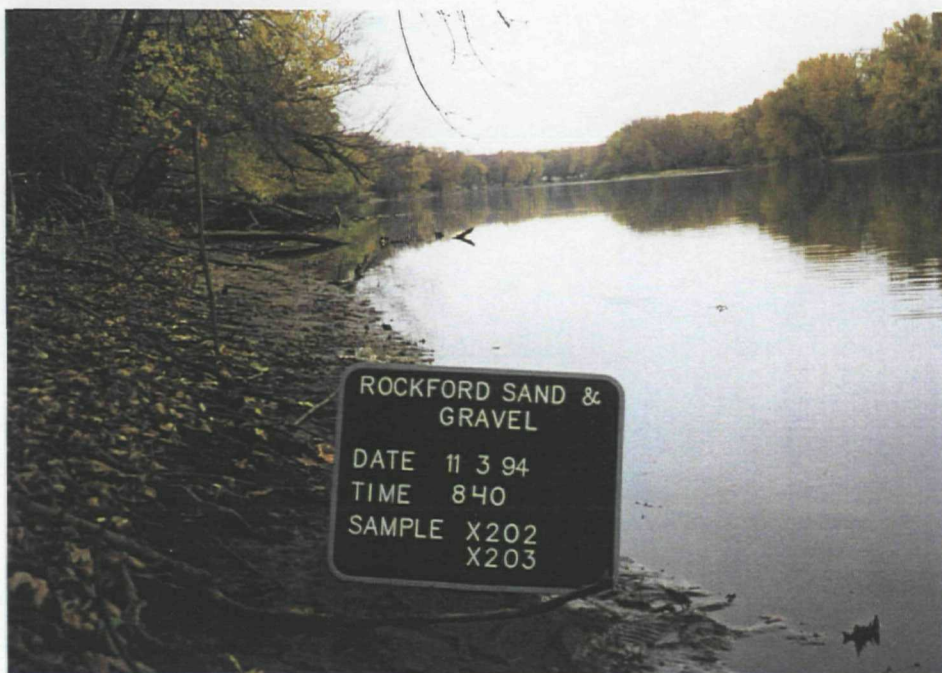
PICTURE TAKEN TOWARD  
the north.

Sample X202 and duplicate  
X203 were collected along  
the Rock River  
approximately 210 feet  
north of Simpson road at  
a depth of 0 to 4 inches.

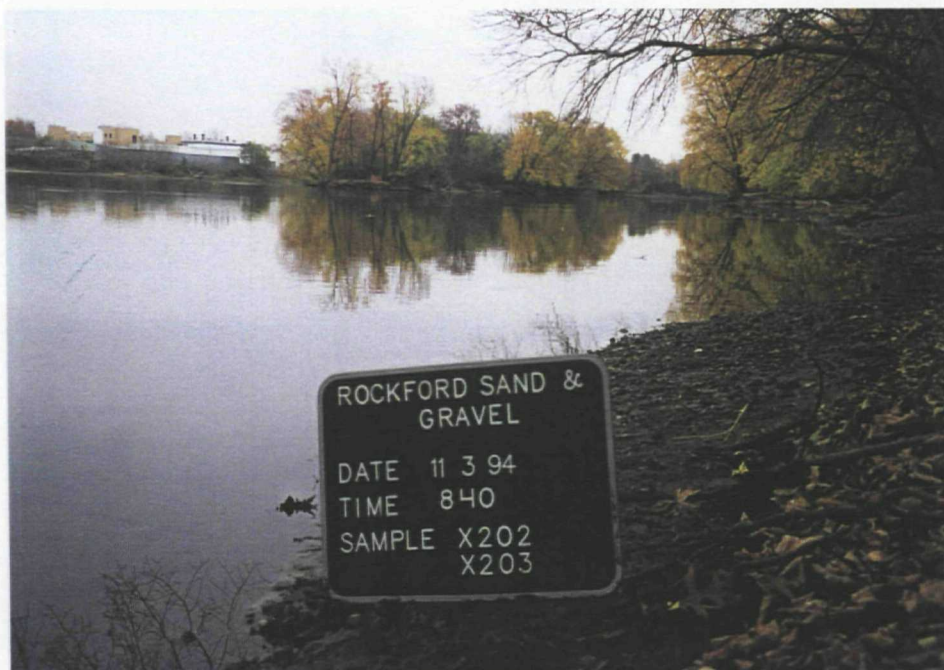
PICTURE TAKEN TOWARD  
the south.

Sample X202/X203. The  
Rockford Sand and Gravel  
property is to the right  
in the photo.

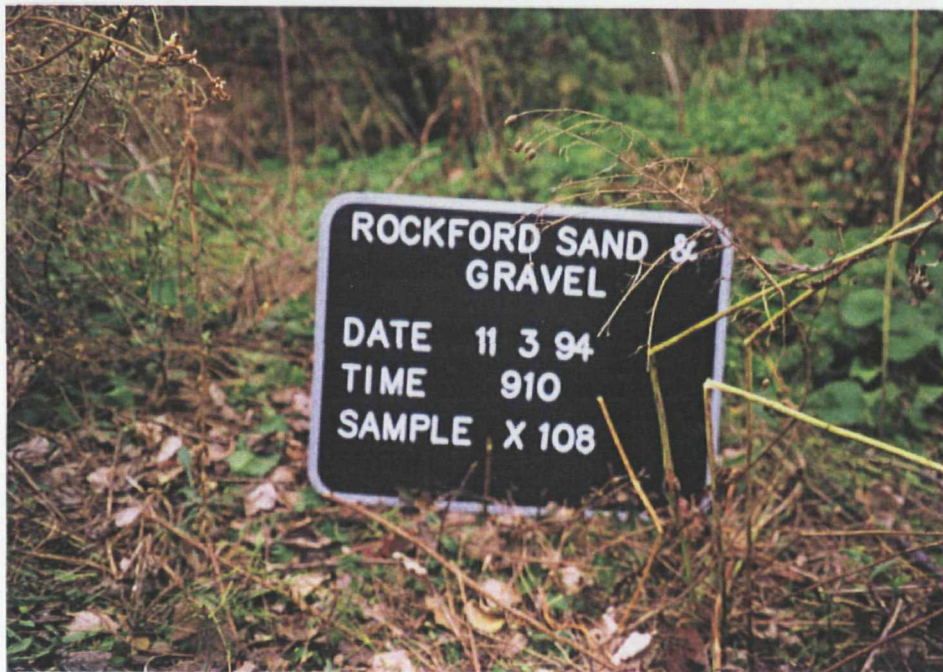
PICTURE TAKEN TOWARD  
the north.

Sample X108 was collected  
at the southeastern end  
of the property 173 feet  
south of monitoring well  
G105.

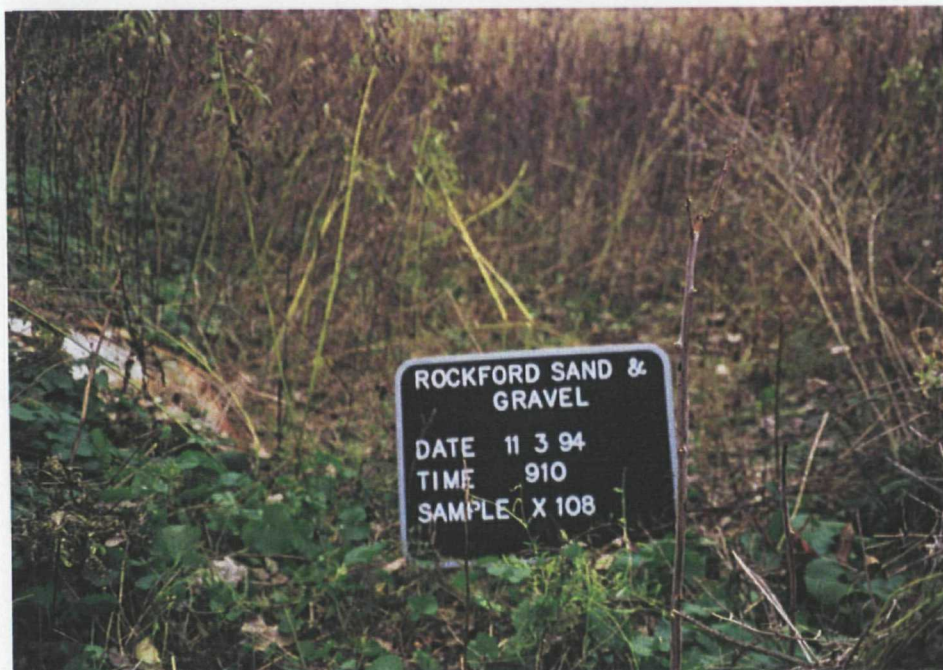
PICTURE TAKEN TOWARD  
the southwest-west

Sample X108 collected at  
a depth of 8 to 12 inches.

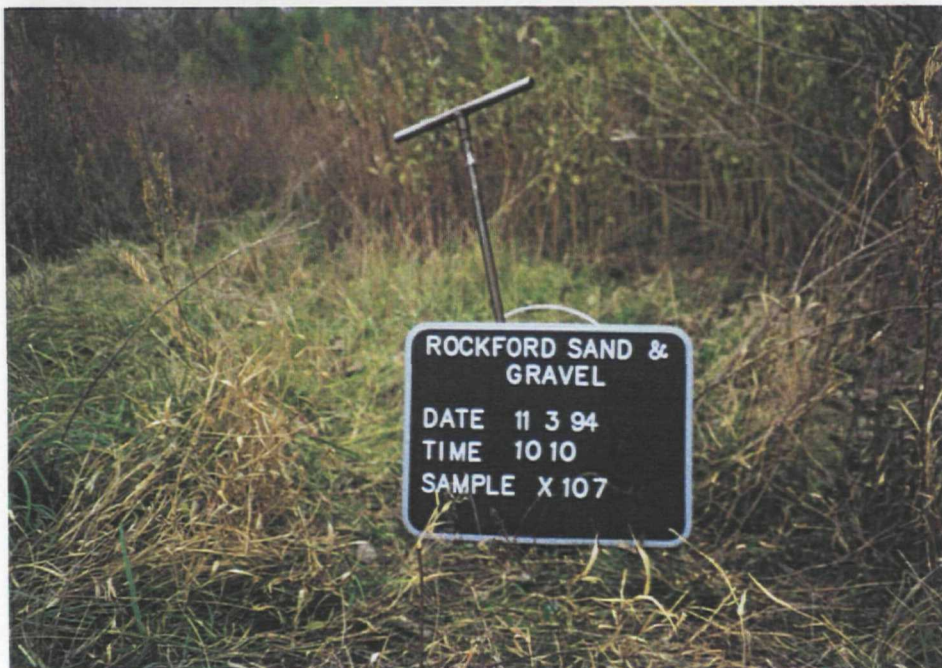
PICTURE TAKEN TOWARD  
the north.

Sample X107 collected at  
the eastern portion of  
the property approximately  
87 feet south of monitor  
well G106/G107.

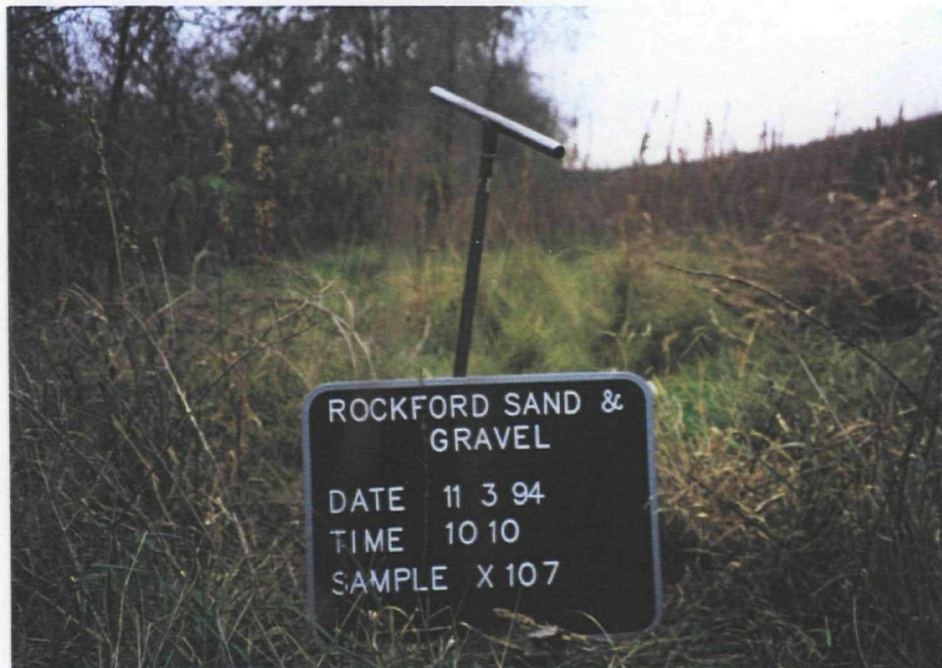
PICTURE TAKEN TOWARD  
the south.

Sample X107 was collected  
from a depth of 8 to 12  
inches.

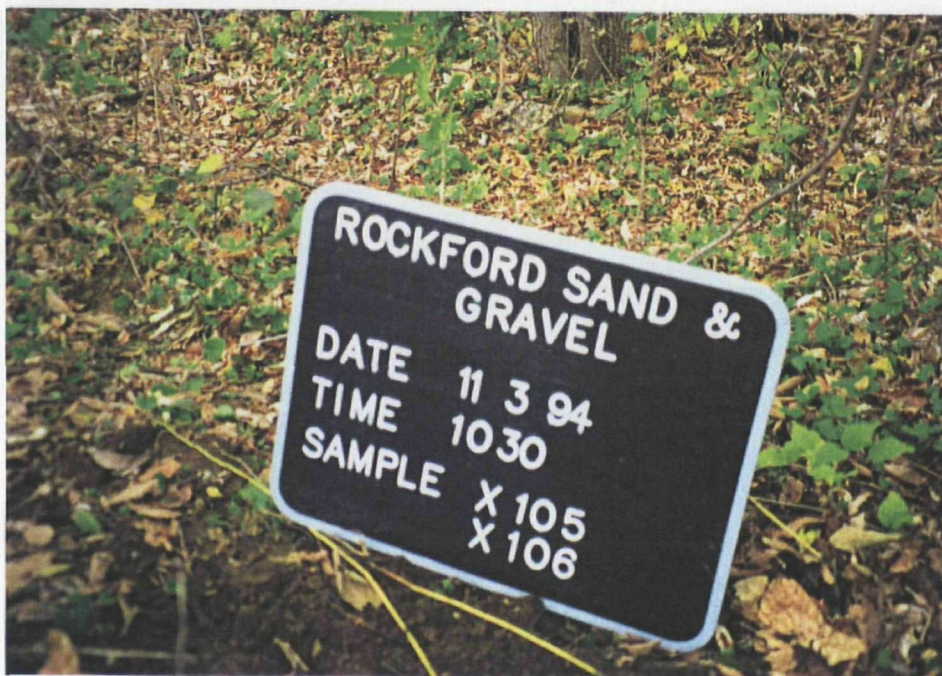
PICTURE TAKEN TOWARD  
the north.

Sample X105 and duplicate  
X106 were obtained from  
the northeastern portion  
of the property.

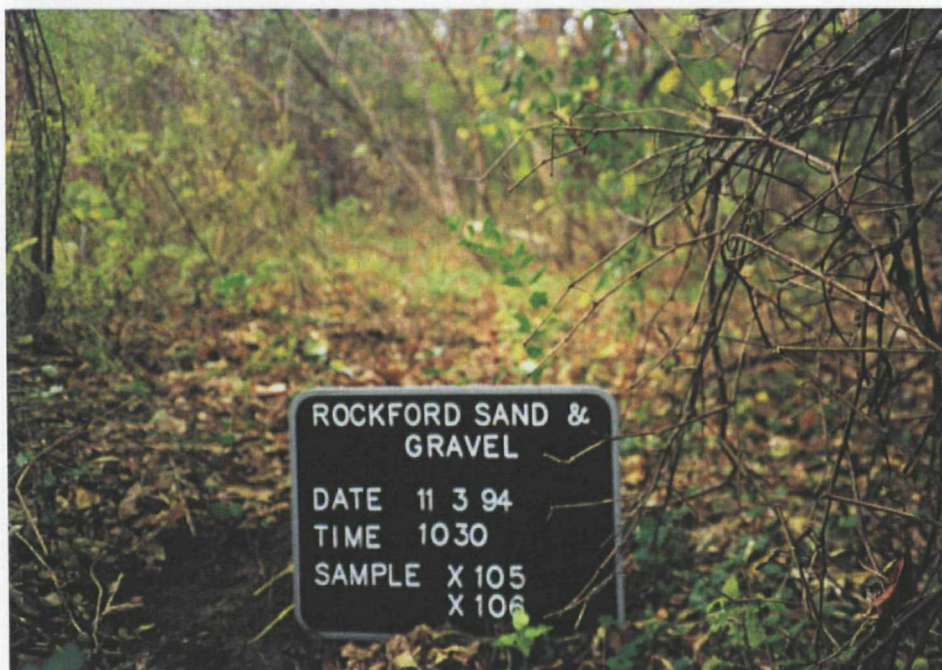
PICTURE TAKEN TOWARD  
the west.

Sample X105/X106 was  
obtained at a depth of 2  
to 6 inches.

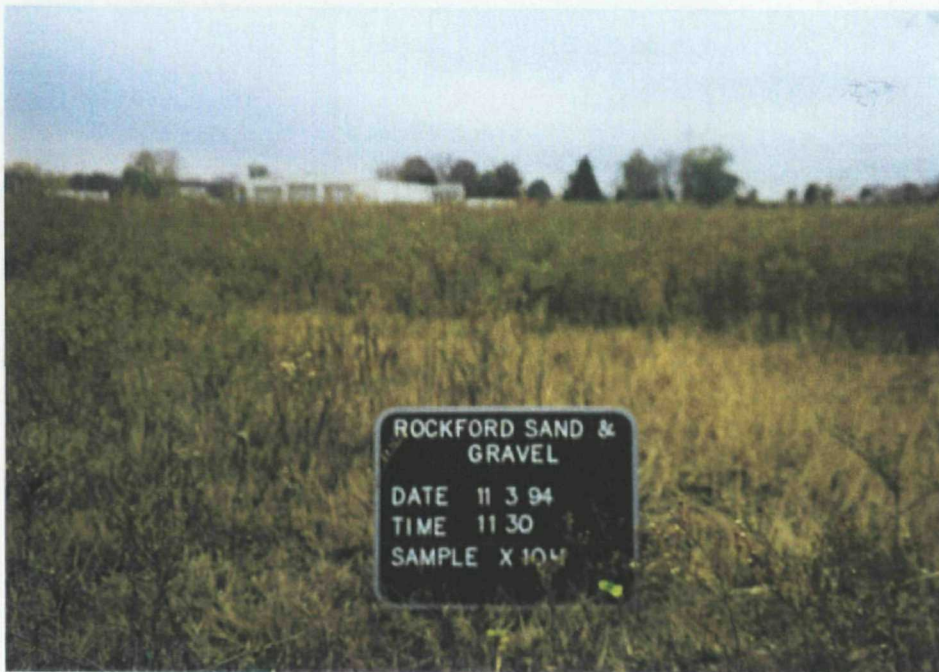
PICTURE TAKEN TOWARD  
the west.

Sample X104 was obtained  
in the south central .  
area of the property.  
Laidlaw waste disposal  
company is in the top  
background.

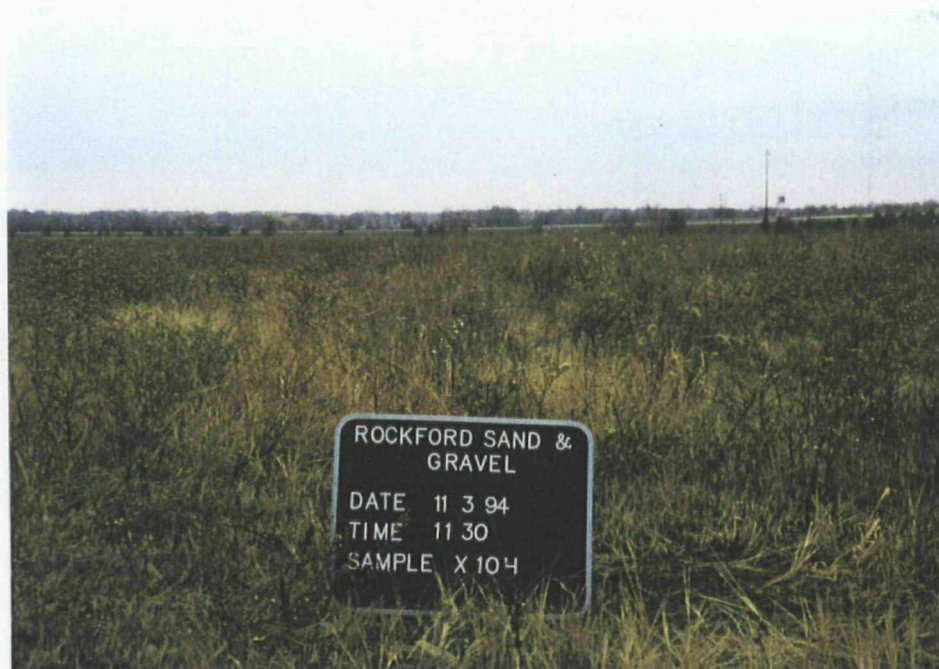
PICTURE TAKEN TOWARD  
the south.

Sample X104 was collected  
at a depth of 12 to 24  
inches.

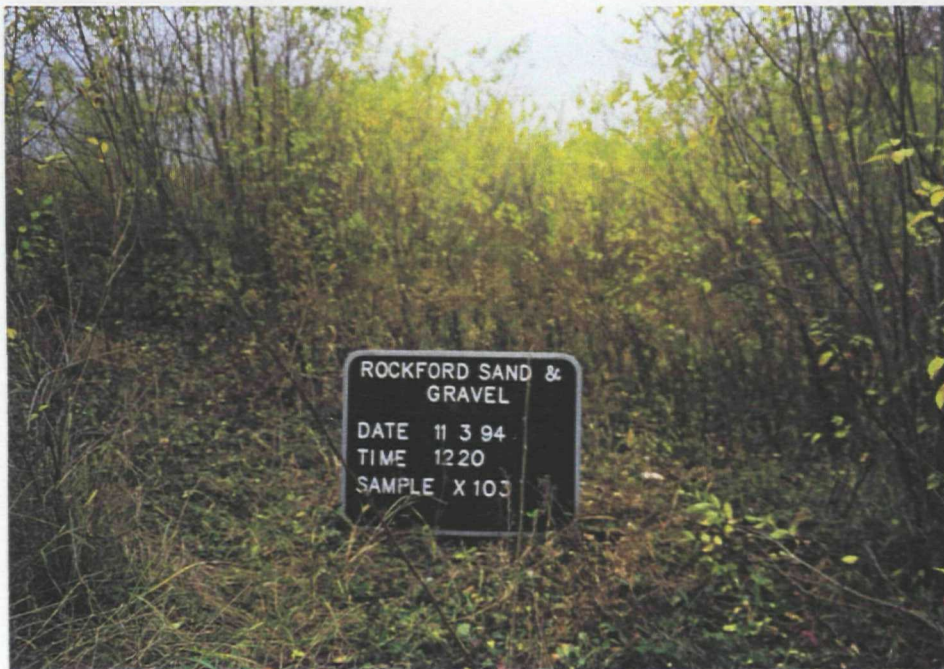
PICTURE TAKEN TOWARD  
the west.

Sample X103 was collected  
near the north end of the  
property approximately  
105 feet west and 94 feet  
south of monitoring well  
G104.

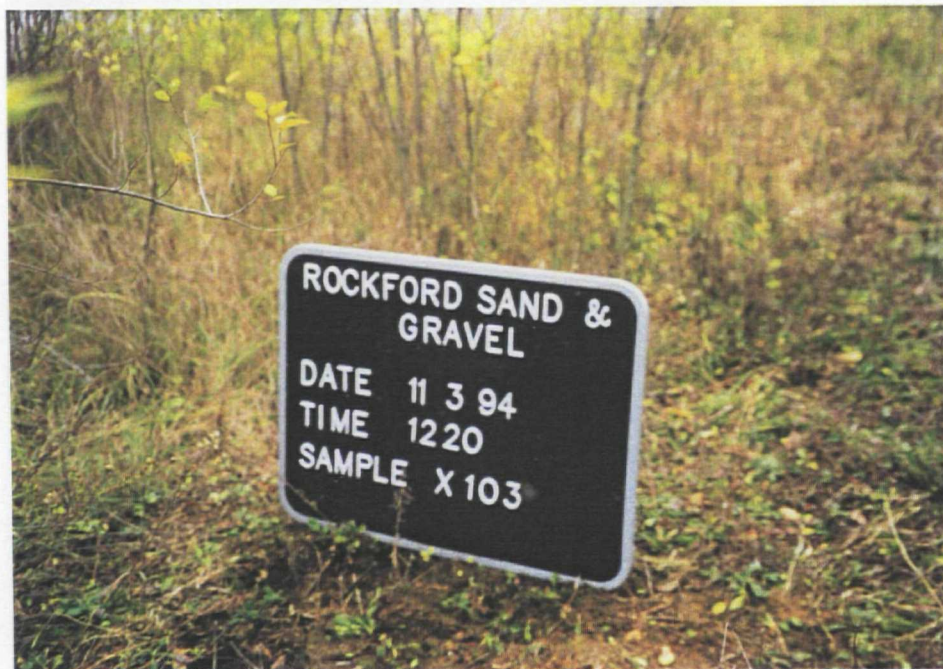
PICTURE TAKEN TOWARD  
the south.

Sample X103 was collected  
at a depth of 6 to 12  
inches.

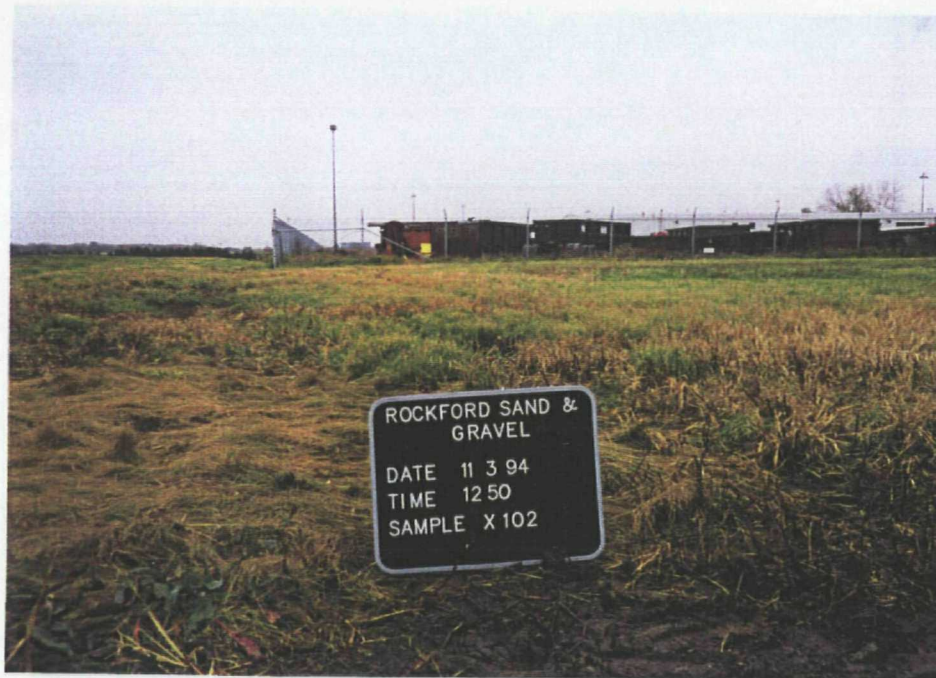
PICTURE TAKEN TOWARD  
the south.

Sample X102 was collected  
approximately 143 feet  
north of the Laidlaw  
facility.

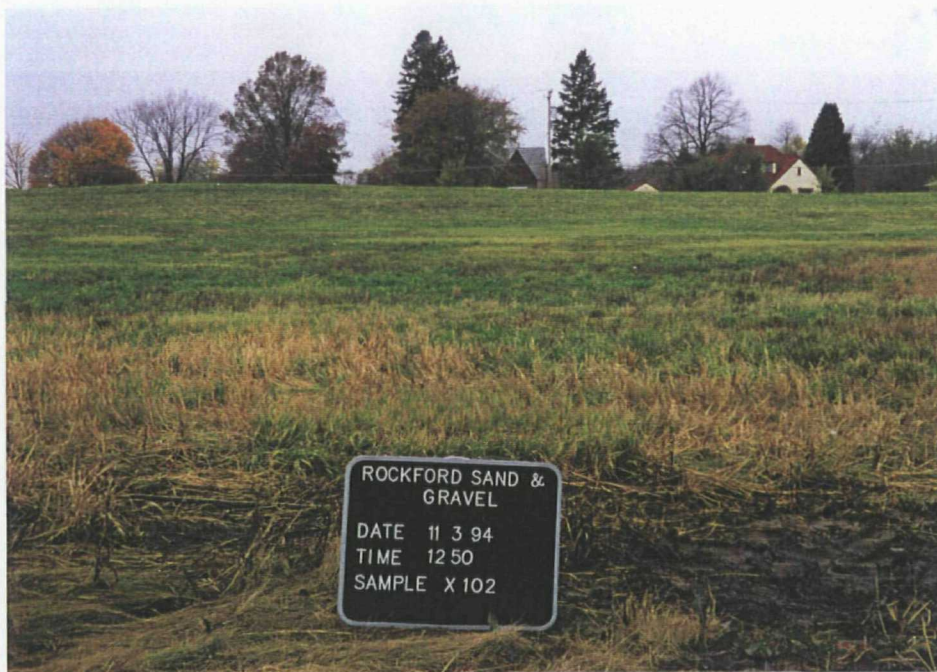
PICTURE TAKEN TOWARD  
the west.

Sample X102 was collected  
at a depth of 3 to 6  
inches. The houses in the  
background lie across So.  
Main Street (Route 2),  
which borders the  
property on the west.

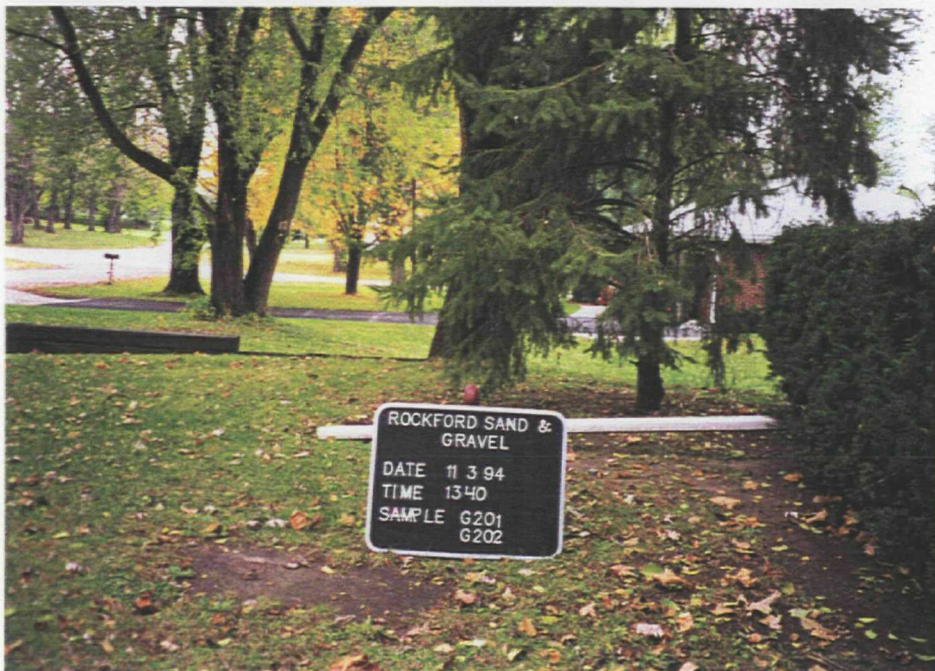
PICTURE TAKEN TOWARD  
the north.

Sample G201 and duplicate  
G202 collected at a  
private residence located  
approximately 500 feet  
north of the property.

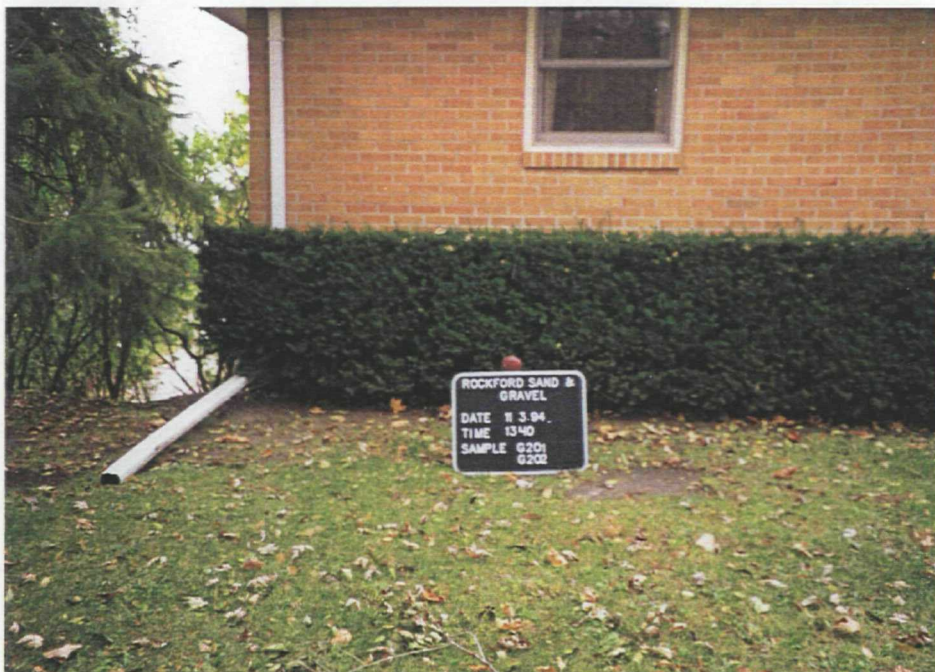
PICTURE TAKEN TOWARD  
the east.

Sample G201/G202 obtained  
from a 75 feet deep  
residential well.

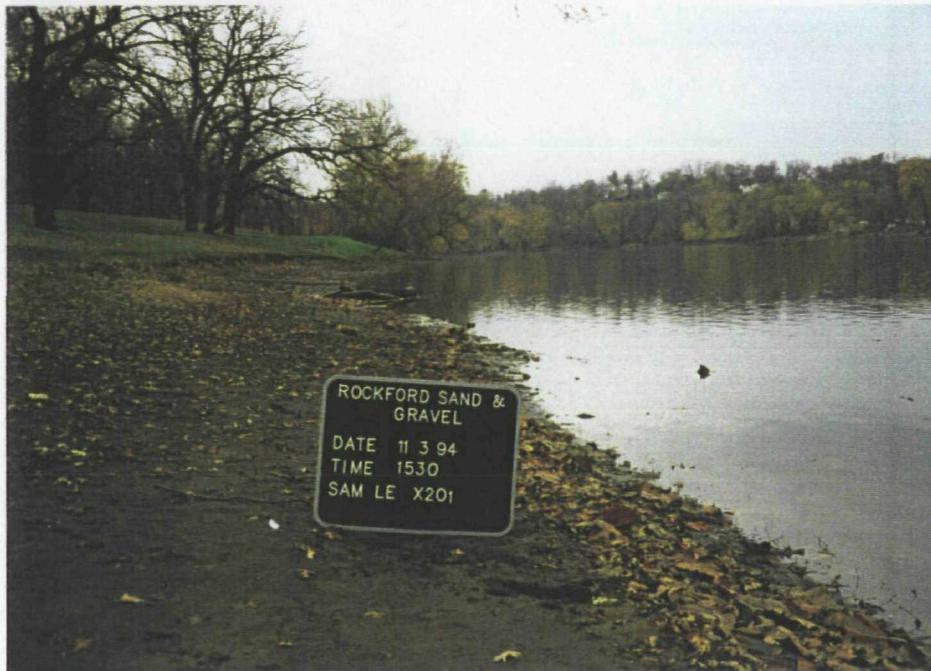
PICTURE TAKEN TOWARD  
the south.

Background sediment  
sample G201 collected  
1.4 miles upstream from  
the Rockford Sand and  
Gravel property in Black-  
hawk Park.

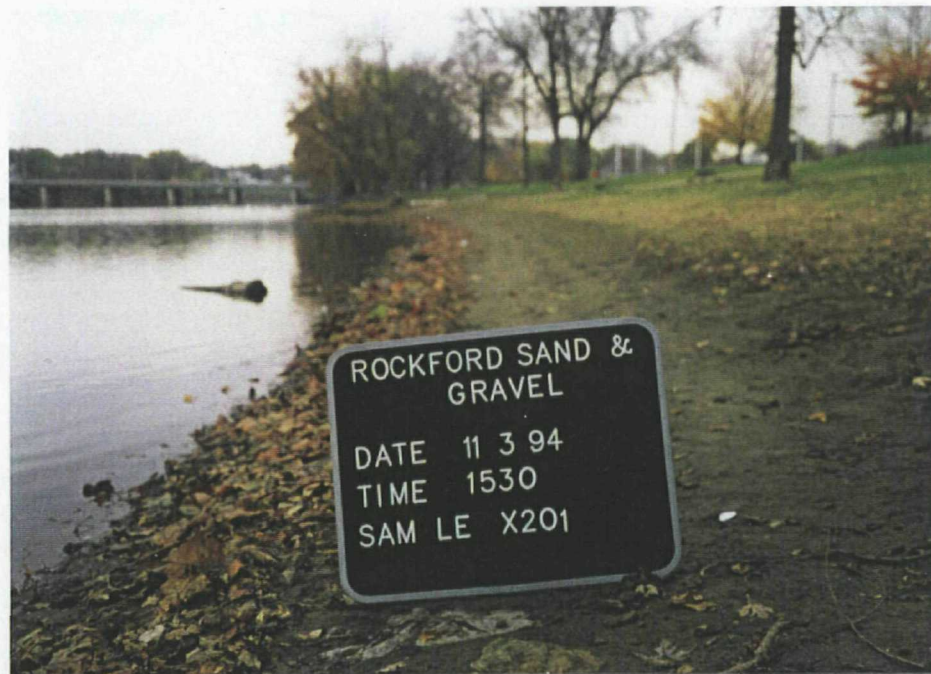
PICTURE TAKEN TOWARD  
the north.

Sample X201 collected at  
a depth of 1 to 3 inches.

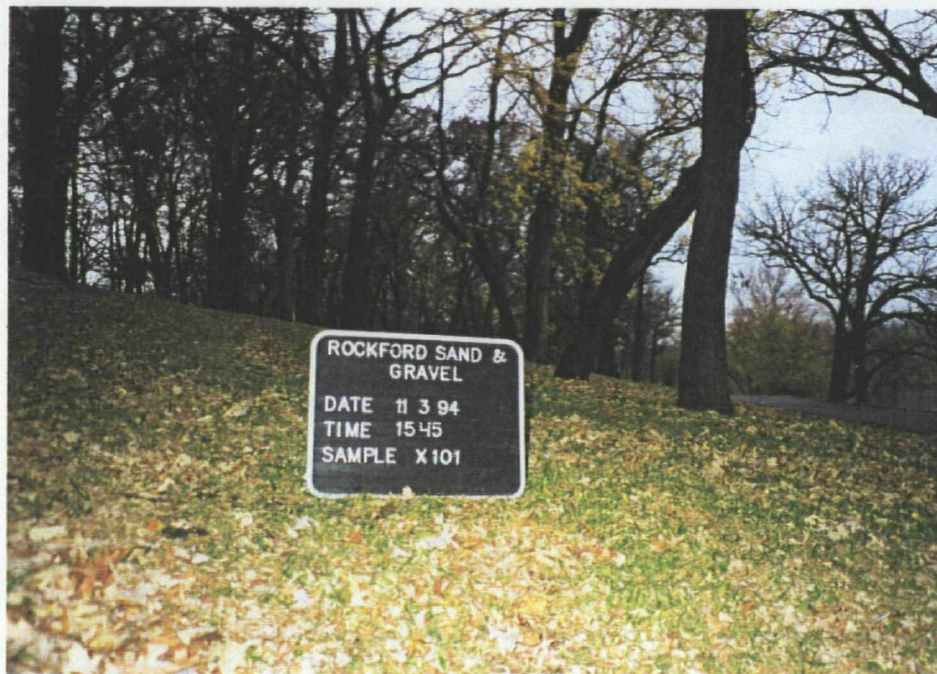
PICTURE TAKEN TOWARD  
the south.

Sample X101 collected in  
Blackhawk Park at a depth  
of 2 to 4 inches.

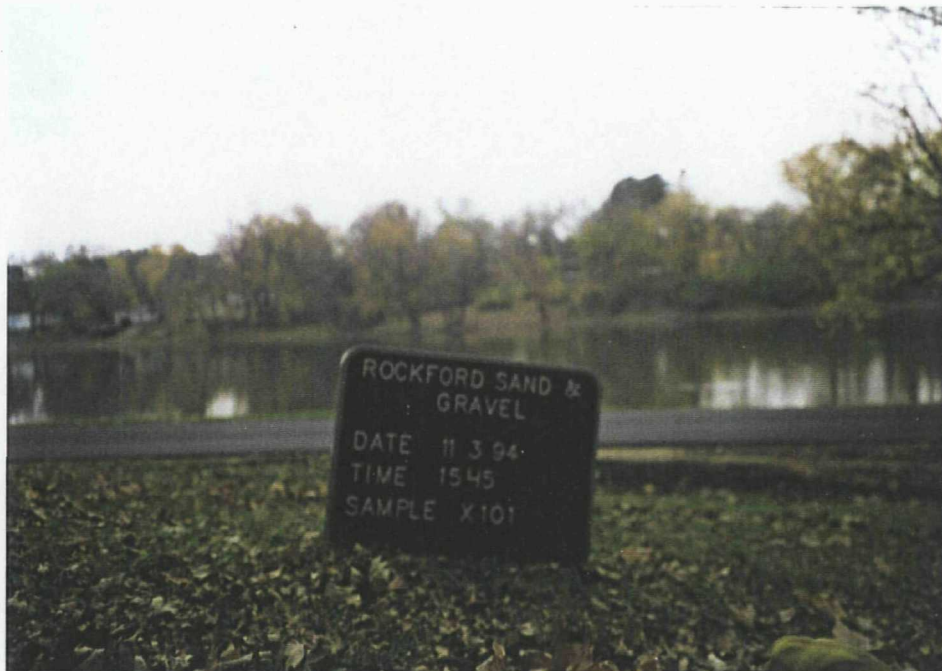
PICTURE TAKEN TOWARD  
the west.

Sample X101 collected in  
a lightly wooded area.
